New Hampshire Volunteer Lake Assessment Program

2002 Interim Report for Otter Pond Sunapee

Otter Pond, Sunapee

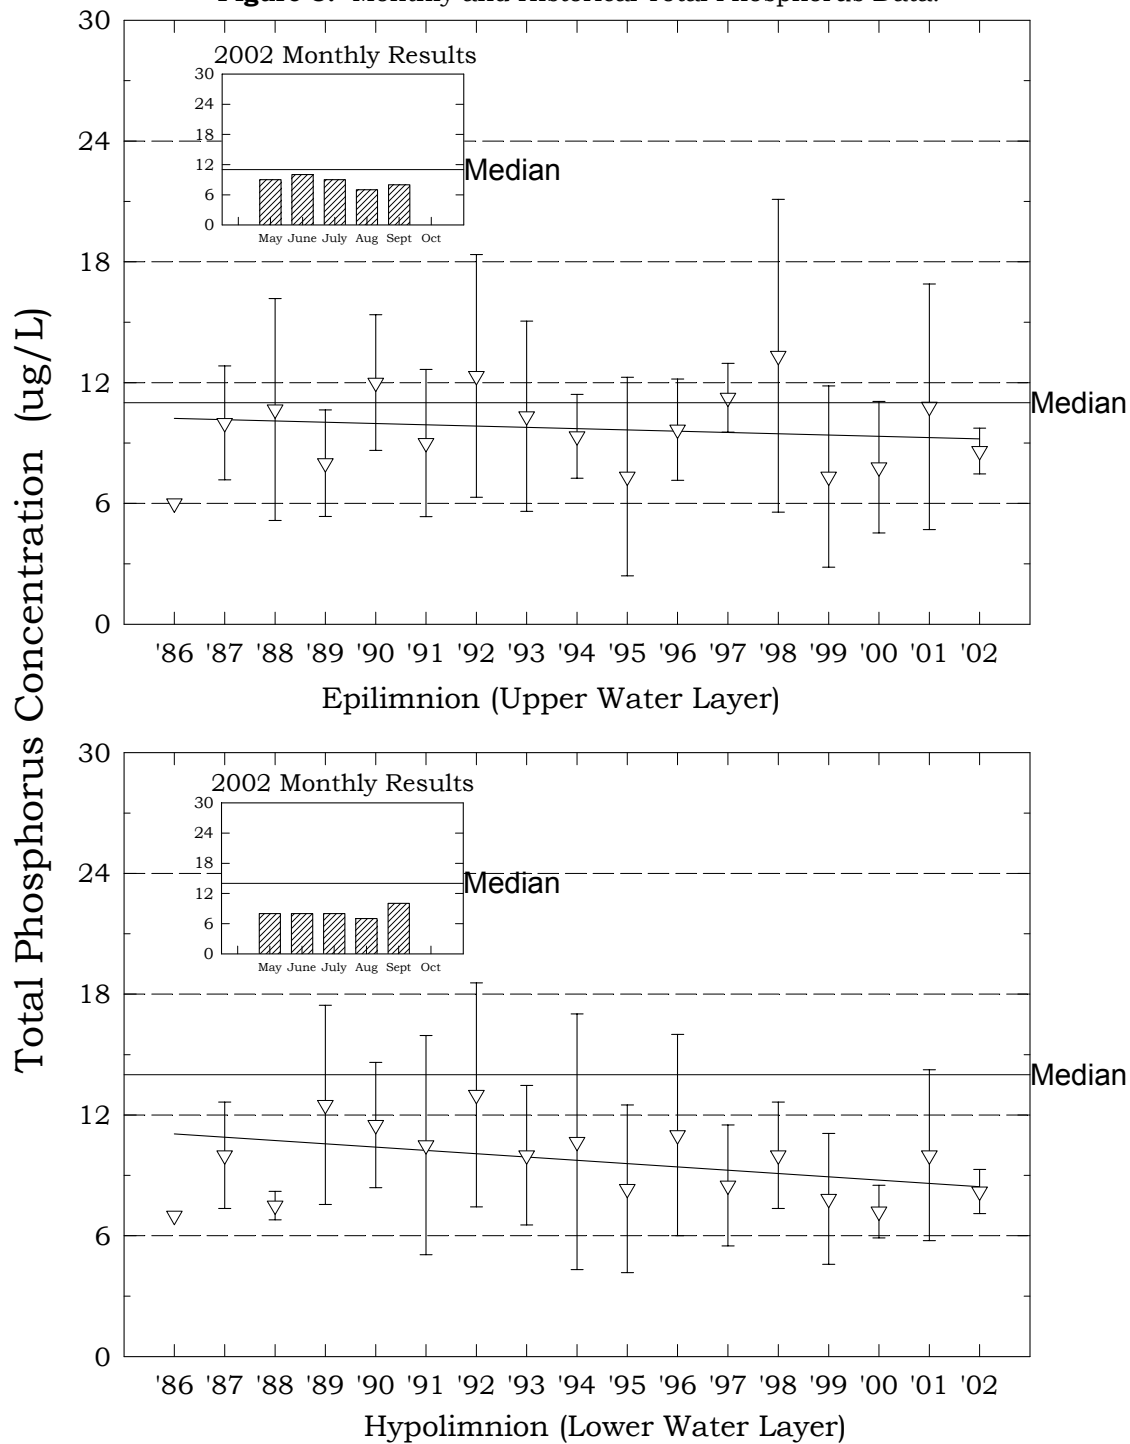
Figure 3. Monthly and Historical Total Phosphorus Data.

- **Figure 3 and Table 8:** The graphs in Figure 3 (Appendix A) show the amounts of phosphorus in the epilimnion (the upper layer) and the hypolimnion (the lower layer); the inset graphs show current year data. Table 8 (Appendix B) lists the annual maximum, minimum, and median concentration for each deep spot layer and each tributary since the pond has joined the program.

The historical data for the epilimnion (upper layer) shows that the 2002 total phosphorus mean is **less than** the state median. Overall, visual inspection of the historical data trend line for the epilimnion shows **a slightly decreasing** total phosphorus trend, which means that the concentration has **improved**, to some extent, in the epilimnion over the years that the pond has been monitored.

The historical data for the hypolimnion (lower layer) shows that the 2002 total phosphorus mean is **less than** the state median. Overall, the historical data trend line for the hypolimnion shows **a decreasing** total phosphorus trend, which means that the

concentration has also **improved** in the hypolimnion over the years that the pond has been monitored.

One of the most important approaches to reducing phosphorus loading to a waterbody is to continually educate watershed residents about its sources and how excessive amounts can adversely impact the ecology and value of lakes and ponds. Phosphorus sources within a lake or pond's watershed typically include septic systems, animal waste, lawn fertilizer, road and construction erosion, and natural wetlands. If you would like to educate watershed residents about how they can help to reduce phosphorus loading into the lake/pond, please contact the VLAP Coordinator.
